Hot Corrosion Studies of Plasma-sprayed MWCNTs- Al_2O_3 Composite Coatings in Molten Salt Environment at 900°C

This research work enquires the hot corrosion behavior of plasma coated boiler steel in the salt environment under cyclic conditions. The coating was carried out by alumina and CNT reinforced alumina composite powders. The substrates were tested in a tube furnace at 900°C. After exposure, thermogravimetric analysis was carried out with XRD, SEM, and EDS analysis to appraise the corrosion phenomenon. The present research concludes that CNT reinforced alumina coatings provide better corrosion resistance.

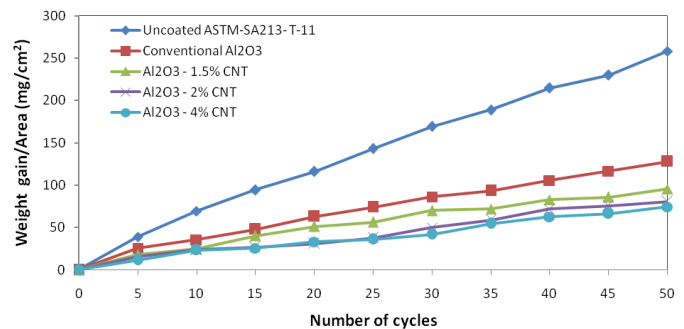
Figure 3: Weight gain/area vs. time (number of cycles) for all specimens after hot corrosion.

The plots for weight gain/ unit area (mg/cm^2) versus time expressed in number of cycles for uncoated and coated T11 steel are shown in Fig.3. The plots for all the samples show high weight gain during initial cycles followed. After the weight gain took place gradually. It is clear from the plots that uncoated T11 steels have shown higher corrosion in comparison to the coatings. Conventional Al_2O_3 coating too has decreased the weight gain. CNTs mixed Al_2O_3 coatings has shown lesser weight gain in comparison to uncoated and $0Al_2O_3$ coated T11 steel. Figure4 shows

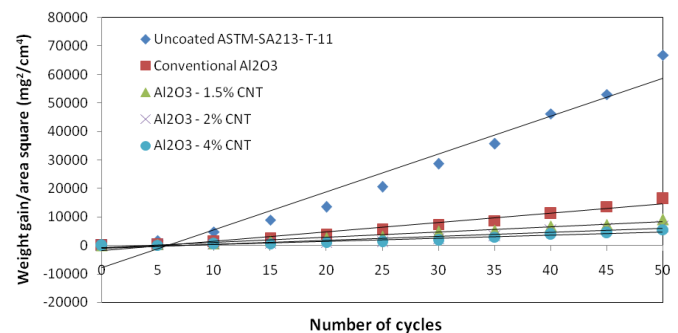
Figure 4: $(\text{Weight gain/area})^2$ vs. time (number of cycles) for all specimens after hot corrosion.

the plots of $(\text{weight gain}/\text{area})^2$ versus number of cycles for all coatings depicts that all coatings have approximately obeyed parabolic rate law. The parabolic rate constant K_p was with the formula $(W/A)^2 = K_p t$, where W/A is the weight change per unit surface area (mg/cm^2) and "t" is number of cycles of experiment. The parabolic rate

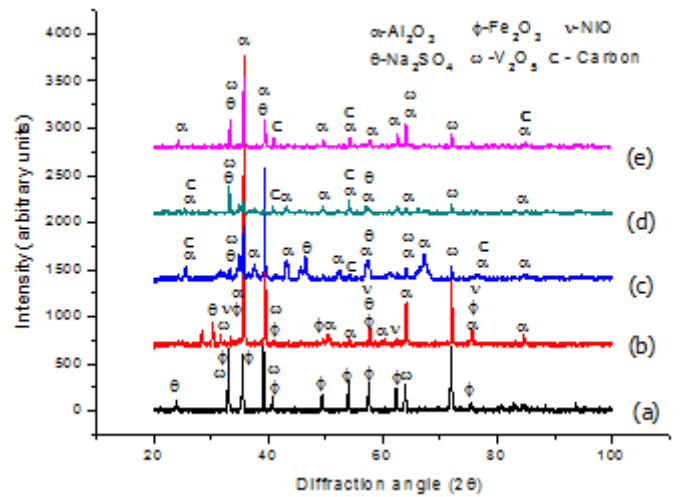
Figure 5: (XRD peaks of (a) Uncoated T11, (b) 0 $CaAl_2O_3$ coating, (c) 1.5 $CaAl_2O_3$ coating, (d) 2 $CaAl_2O_3$ coating, (e) 4 $CaAl_2O_3$ coating after hot corrosion.

X-ray peaks for uncoated, 0 $CaAl_2O_3$, 1.5 $CaAl_2O_3$, 2 $CaAl_2O_3$ and 4 $CaAl_2O_3$ coated steels after cyclic corrosion testing is given in Fig.5 (a-e). The formation of oxides of Fe could be identified in case of bare steel. The prominent phase noticed for this steel is Fe_2O_3 . Al_2O_3 was noticed as the major phase formed in the 0 $CaAl_2O_3$ coated T11 steel after exposure to the molten salt surroundings (Fig.5 (b)). Minor peaks of NiO, Na_2SO_4 , Cr_2O_3 and Fe_2O_3 phases has also been detected. In the case of 1.5 $CaAl_2O_3$, 2 $CaAl_2O_3$ and 4 $CaAl_2O_3$ coated T11 steels (Fig.5 (c-e)), Al_2O_3 was detected as the main phase and carbon, Na_2SO_4 and V_2O_5 has been observed as the minor XRD phases.

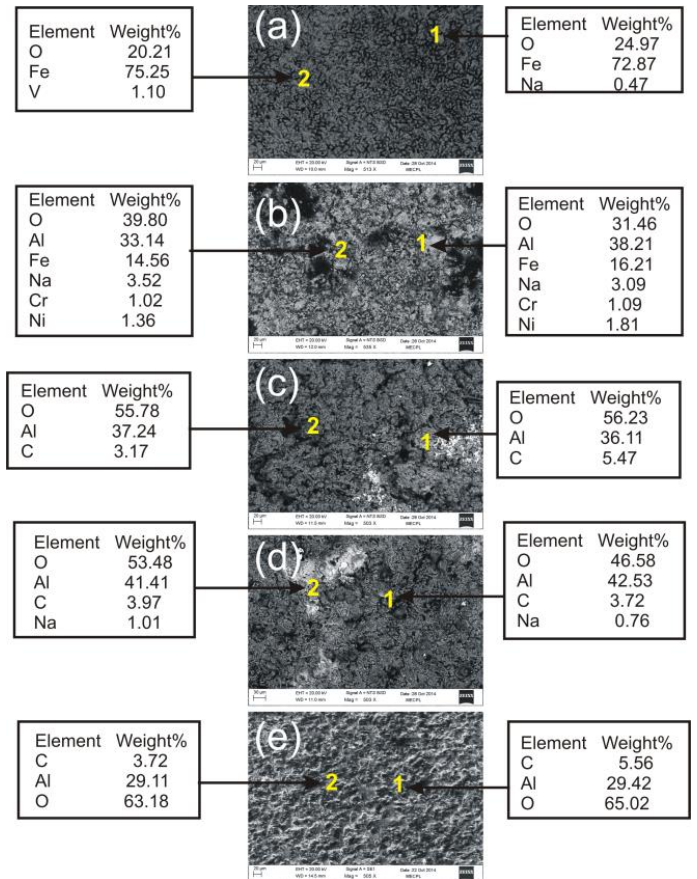
Figure 6: FE-SEM and EDS analysis of: (a) Uncoated T11, (b) 0 $CaAl_2O_3$ coating, (c) 1.5 $CaAl_2O_3$ coating, (d) 2 $CaAl_2O_3$ coating, (e) 4 $CaAl_2O_3$ coating after hot corrosion.

FE-SEM and EDS analysis for uncoated as well as coated T11 steel samples after testing is presented in Fig.6. The surface morphology of uncoated steel (Fig.6 (a)) indicated irregular flakes with random orientation. The scale appears to be porous. In EDS analysis of uncoated steel at points 1 and 2 in the micrograph, it was noted that the scales are concentrated with O and Fe and a small amount of elements such as Na and V was also observed. The presence of O and Fe confirmed the formation of Fe_2O_3 phase, which were noted in XRD analysis of the same substrates. Figure6 (b) shows surface morphology of 0 $CaAl_2O_3$ coated specimen as thick irregular flake scales. In EDS analysis of 0 $CaAl_2O_3$ coated T11 steel exposed to molten salt environment, it was noted that the scale was rich in Al, O and Fe elements and some amount of Na, Ni, and Cr elements also found. These elements led to the formation of Al_2O_3 , Fe_2O_3 , Na_2SO_4 , Cr_2O_3 and NiO phases. The micrograph of

1.5 $CaAl_2O_3$ coated T11 steel (Fig. 6 (c)) showed dense granular scale. In EDS analysis, at points 1 and 2, of the same substrate, it was noted that the along with Al and

O in composition and there is a minor percentage of C in the scale. Figure 6 (d) shows surface morphology of $2CaAl_2O_3$ coated T11 steel substrate after experimentation. In EDS analysis of the same substrate, at points 1 and 2, it was noted that the major elements present in the scale were O and Al there is a minor percentage of C and Na in the scale. The surface morphology of $4CaAl_2O_3$ coated T11 steel substrate exposed to the molten salt environment (Fig.6 (e)) shows dense regular scales. The EDS analysis of the same substrate at point 1 and 2 in the micrograph showed the top scale is rich in Al and O elements and C element is present in a minor amount. The noted elements formed the phases such as Al_2O_3 and of C. The same has been observed from the XRD analysis of same substrate.
